## Upgrade and recapitalization of seismic station AKASG

P4.4-049

The AKASG seismic station (PS45) is located at the territory of Ukraine. From 2000 to 2002, the station was being upgraded according to the CTBTO requirements.

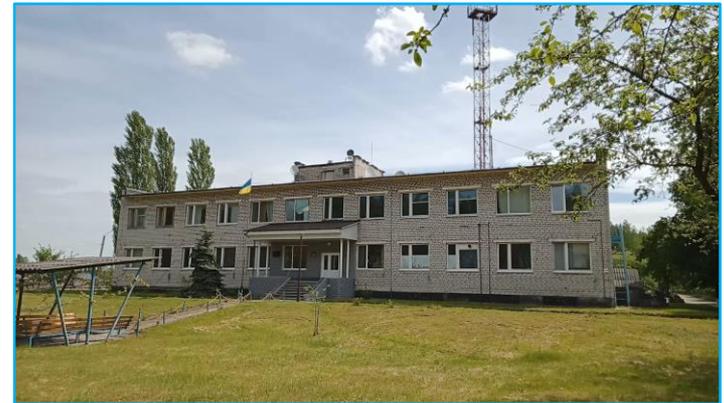
*Fig. 1. The location of the AKASG station and the view of the CF-AKASG site.*

The AKASG (PS45) station is located near the town of Malyn, at the distance of 100 km from Kyiv (Fig. 1). It was originally built in 1976-1979. Until 1992, it had been a member of the Special Control Service of the Soviet Union. The station consists of 24 sites (23 boreholes and 1 vault site) and a central information collection point CF-AKASG.

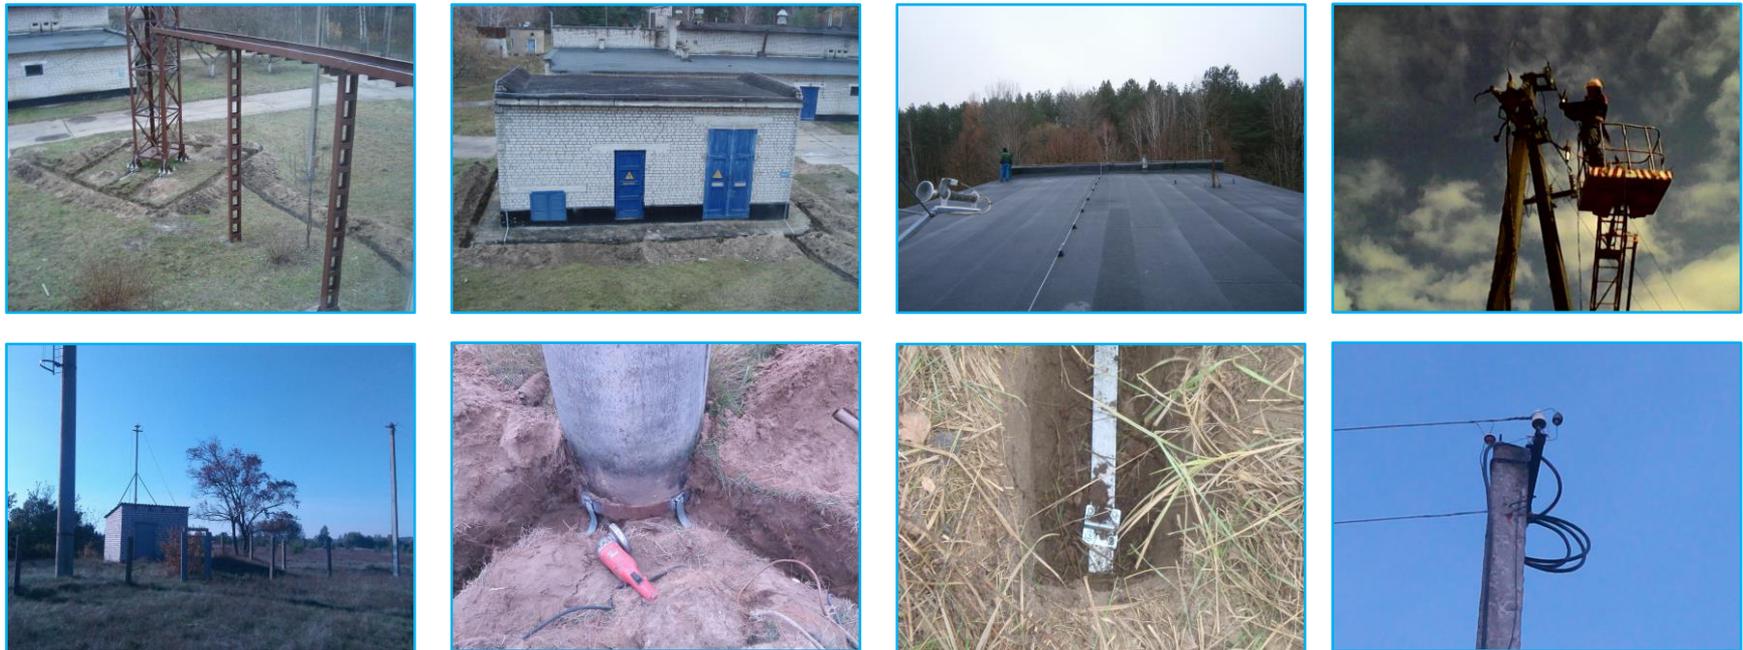
Fig. 3. The upgrade process of the grounding and the lightning protection system at the station sites.

- In 2011-2012, the required work was carried out to improve the grounding and the lightning protection system at the station sites;
- In 2013, the required work was carried out to install the fiber-optic communication lines between the sites of the station;
- in 2014-2015, the required work was carried out to install new power supply and communication equipment at the station sites;
- In April 2016, the required work was carried out to replace the digitizers and the workstations;
- In the summer 2016, the required work was carried out to dismount and dispose the radio communication masts at the station's sites.

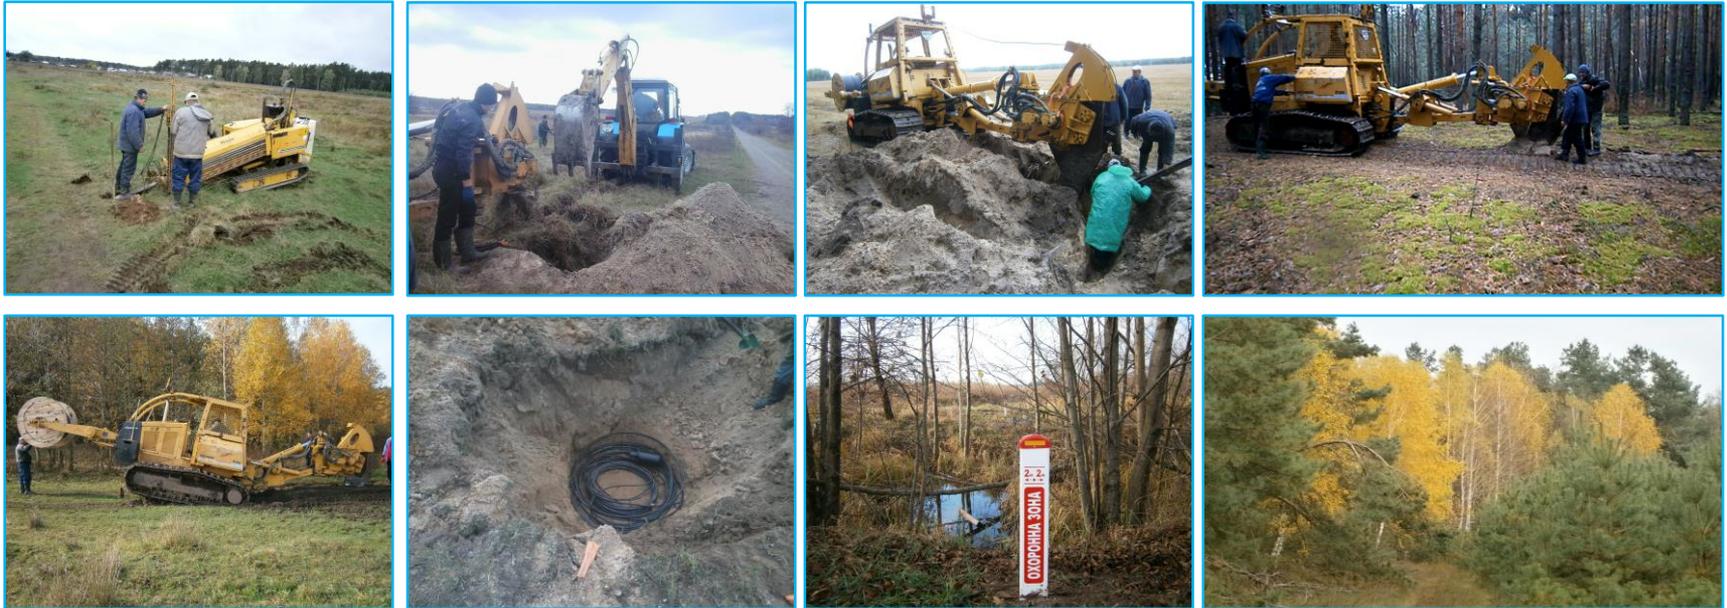
Fig. 4. The process of the fiber-optic communication lines installation.

- replacement of the radio communication lines with the fiber-optic communication lines between station sites;
- improvement of the grounding and lightning protection system at the station sites;
- replacement of the power supply equipment at the station site;
- replacement of the communication equipment at the station site;
- replacement of the digitizers on the station sites;
- replacement of the workstations and their software at the central site of the station;
- dismantling and disposal of the radio communication masts.

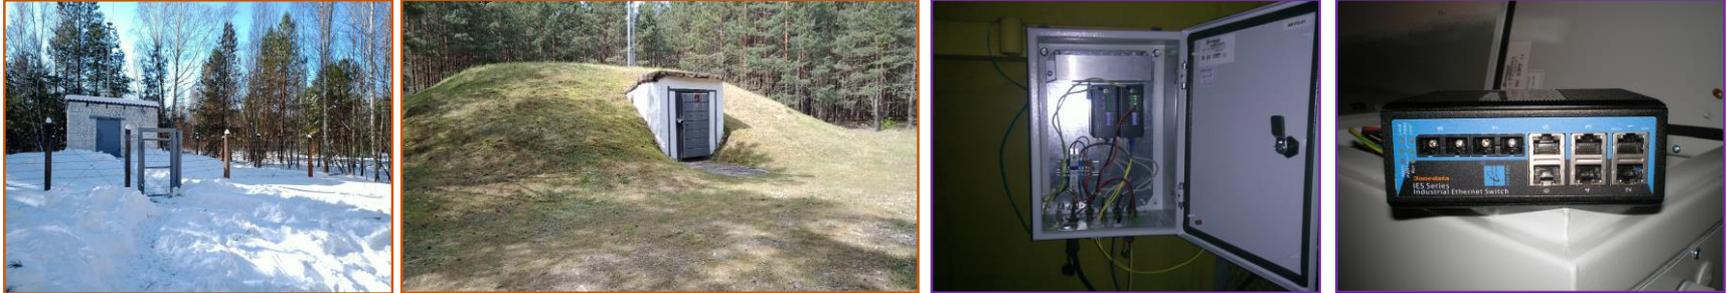
*Fig. 5. The view of two of the remote station sites (the AK02 and AKBB sites).*

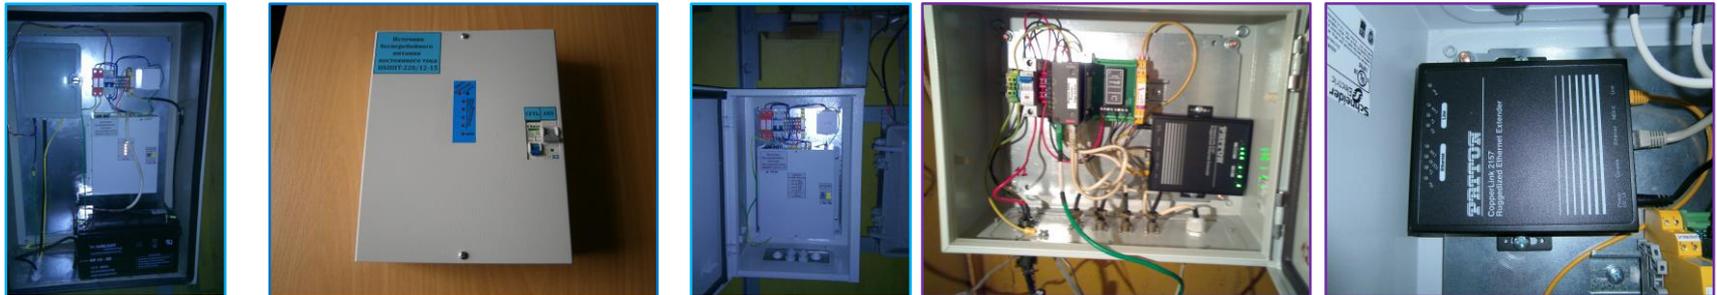
*6. The power supply unit at one of the station site.*

*Fig. 7. The communication equipment at one of the sites of the station.*

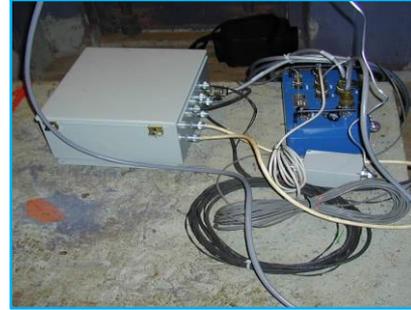
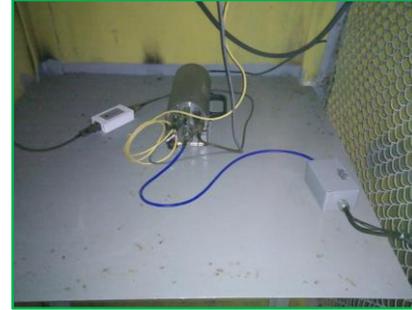
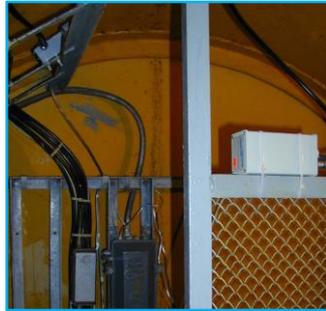
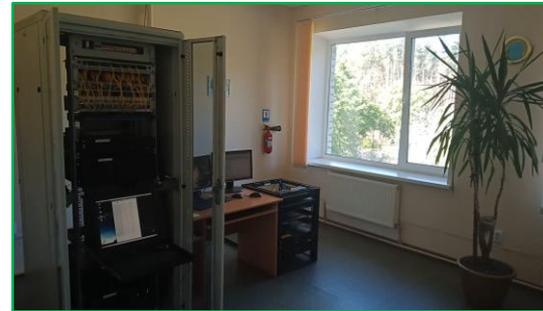
*Equipment removed from the station*

*Equipment installed at the station*

Fig. 8. The photo of both the removed and the installed equipment.

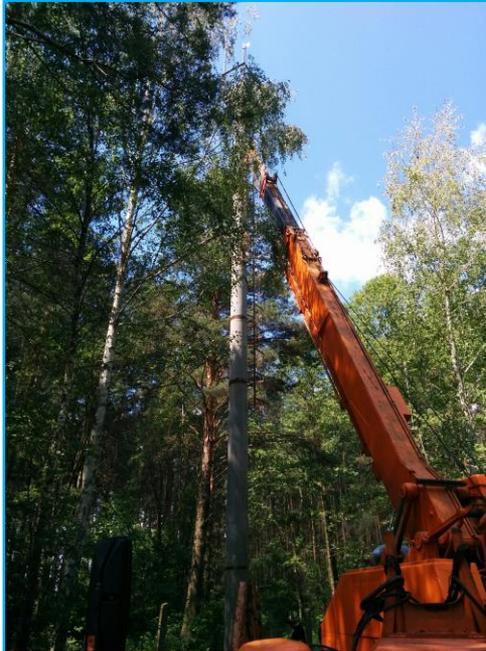
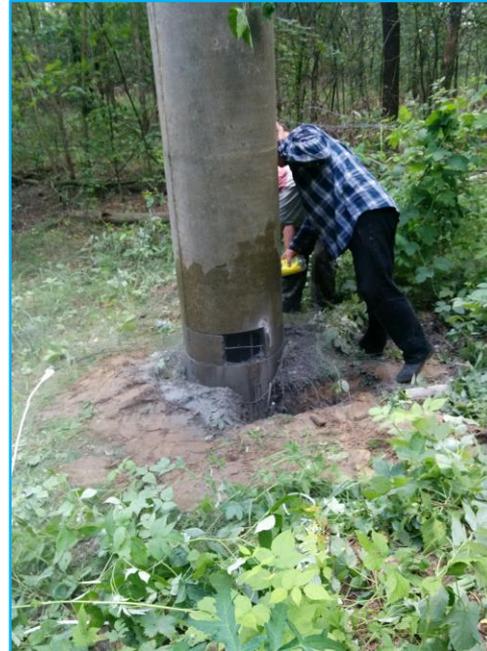
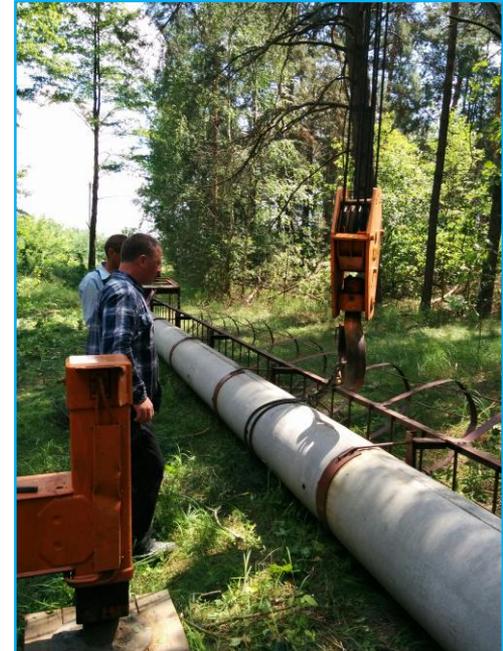
*Fig. 9. The photo of dismantling of the radio communication masts.*
